Manhole Inspection Summary

Manhole # S39YY_012MH

Location Address: **828 33RD ST**

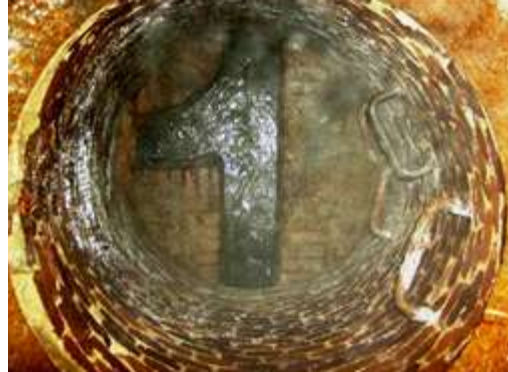
Top View

Corroded steps. Evidence of surcharge - Bench debris.

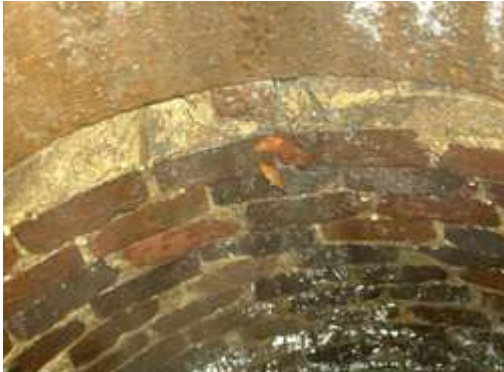
Defect

Frame leaks. Frame offset. Adjustment and Corbel infiltration. Adjustment deterioration.

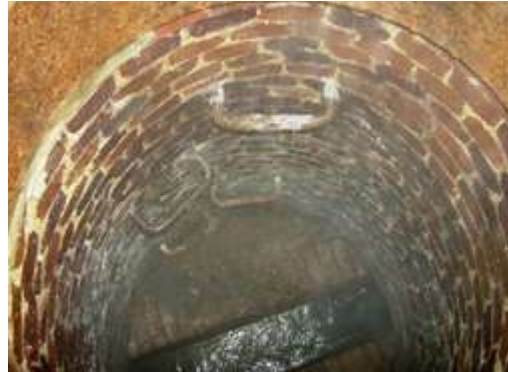
Defect

Frame leaks. Adjustment, Corbel and Barrel infiltration.

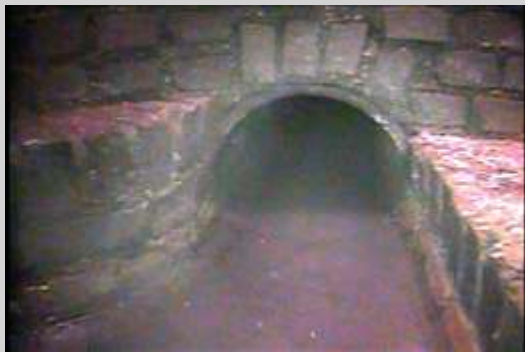
12 in. Circular Gravity Sewer Pipe Out @ 12 O'Clock

Infiltration: **Evidence** Pipe Seal Cond: **Unknown**

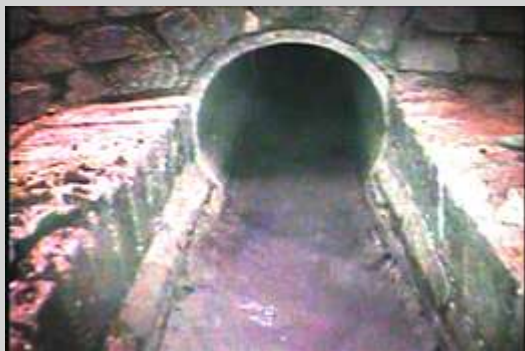
12 in. Circular Gravity Sewer Pipe In @ 6 O'Clock

Barrel deterioration and infiltration. Channel deterioration.

Deposits: ☐ None ☐ Mud ☐ Sludge ☐ Debris ☒ Grease

Infiltration: **Evidence** Pipe Seal Cond: **Unknown**
